INSPECTION REPORT

For the Property at:
2300 SAMPLE STREET
SARASOTA, FL 34236

Prepared for: SAMPLE REPORT
Inspection Date: Monday, January 12, 2009
Prepared by: Tim Beavers

Report No. 1003, v.2

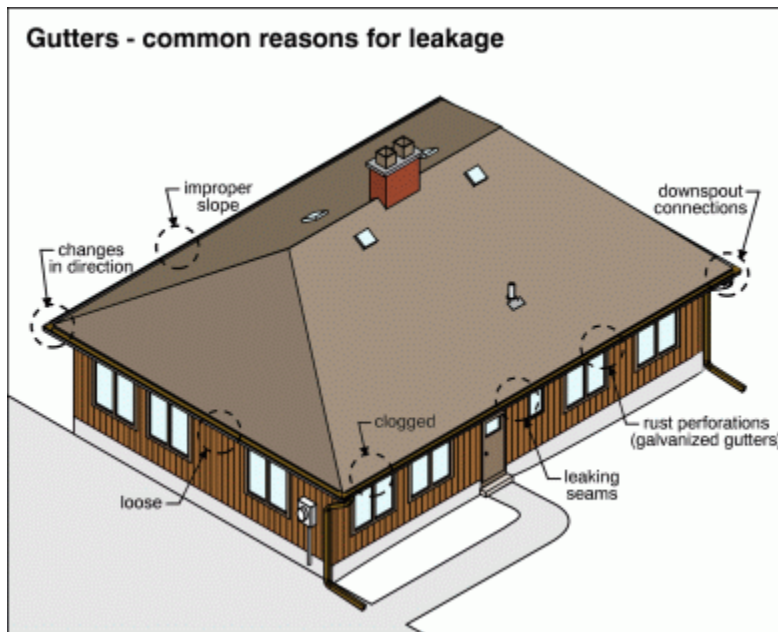
10. Condition: • [Clogged](#)

Implication(s): Chance of water damage to contents, finishes and/or structure

Location: Various

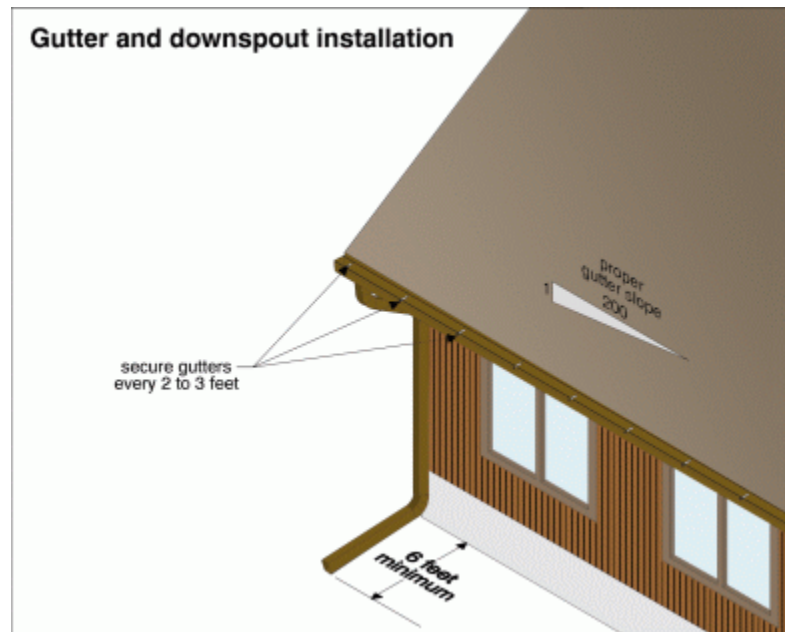
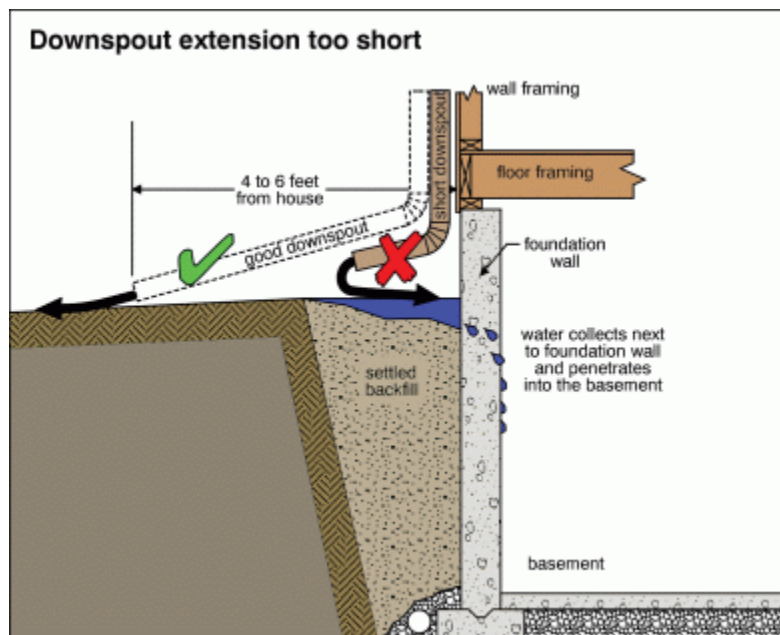
11. Condition: • [Downspouts end too close to building](#)

Implication(s): Chance of water damage to contents, finishes and/or structure

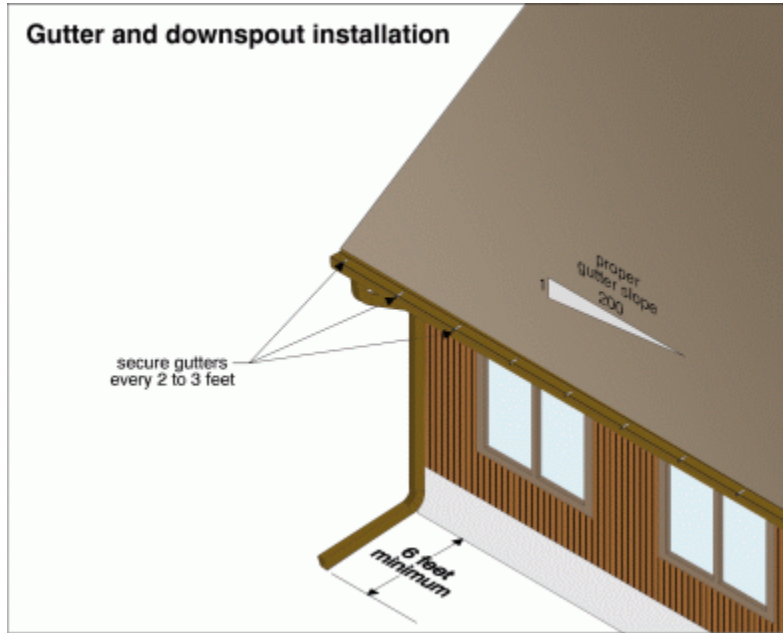
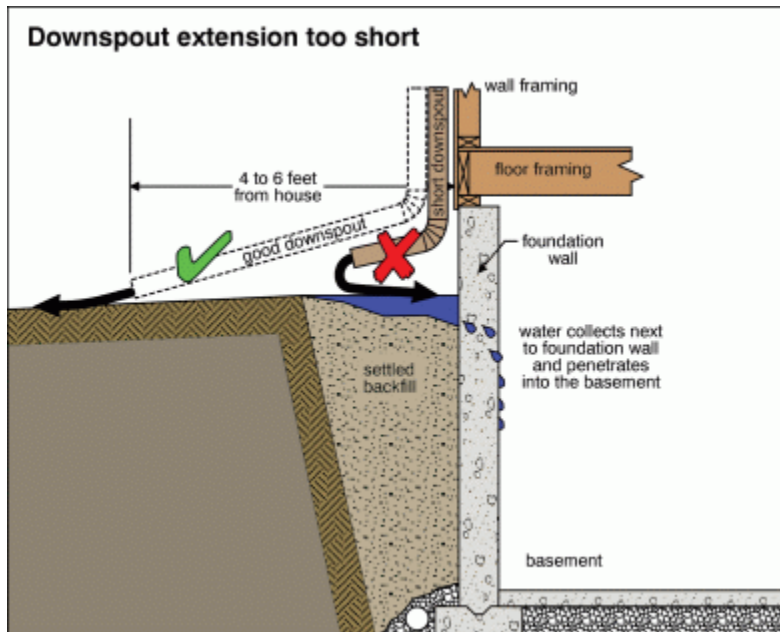
13. Condition: • Should discharge 6ft. from home

Implication(s): Chance of water damage to contents, finishes and/or structure

Location: Rear Left Side

Task: Repair

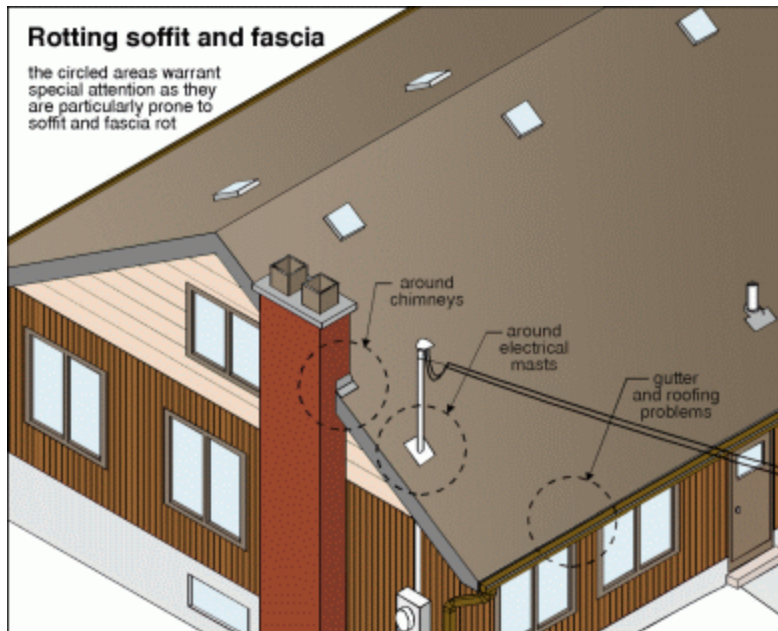
14. Condition: • [Paint or stain needed](#)

Implication(s): Cosmetic defects | Chance of water damage to contents, finishes and/or structure | Shortened life expectancy of material

Location: Various

Task: Improve

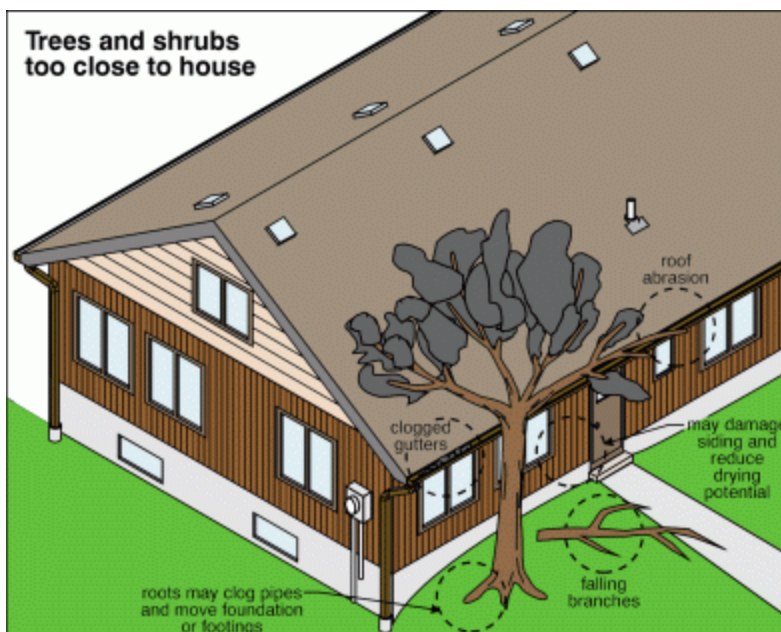
22. Condition: • [Trees or shrubs too close to house](#)

Implication(s): Chance of water damage to contents, finishes and/or structure | Chance of pests entering house | Material deterioration

Location: Various

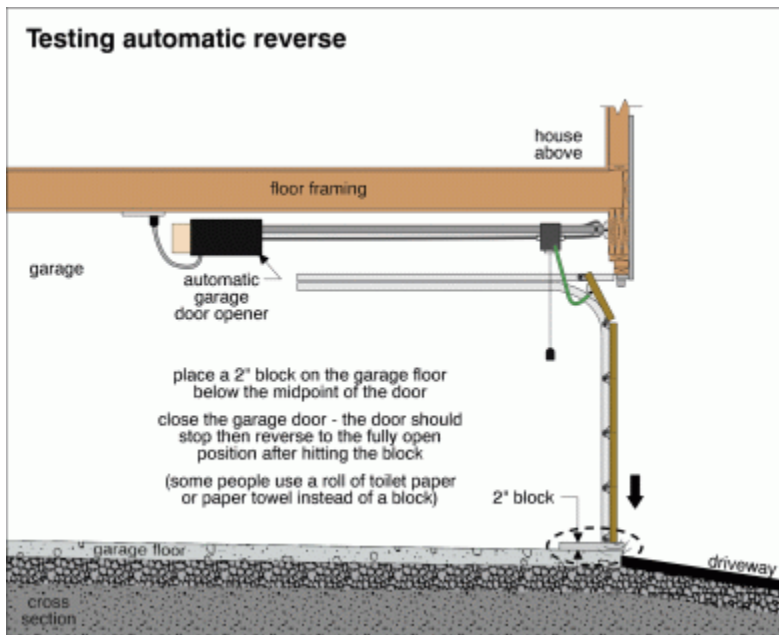
32. Condition: • [Fails to auto reverse](#)

The garage door opener did not automatically reverse under resistance to closing. There is a serious risk of injury, particularly to children, under this condition. The opener may need adjustment or replacement.

Location: Garage

Task: Repair

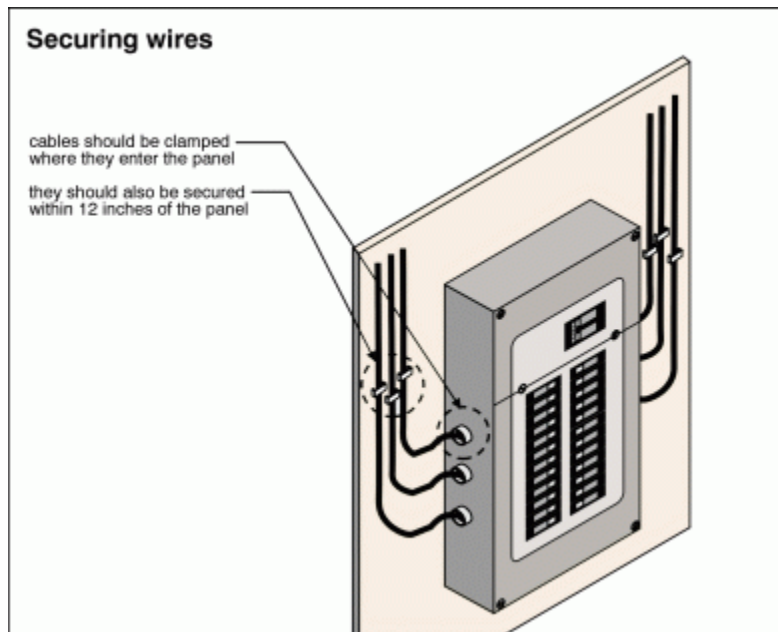
41. Condition: • [Not well secured](#)

Loose wiring should be secured in attic area.

Implication(s): Electric shock | Fire hazard

Location: Various Attic

Task: Repair

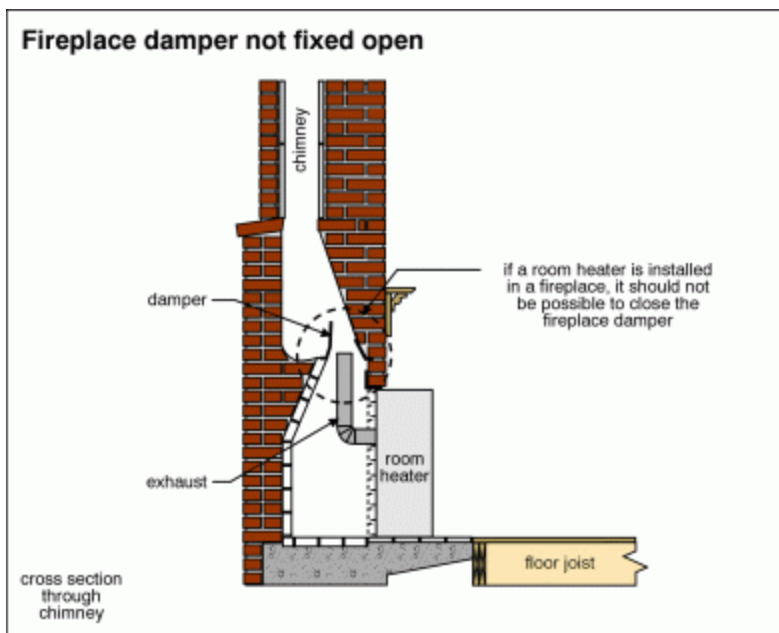
51. Condition: • [Damper in existing fireplace not fixed open](#)

Implication(s): Hazardous combustion products entering home

Task: Replace

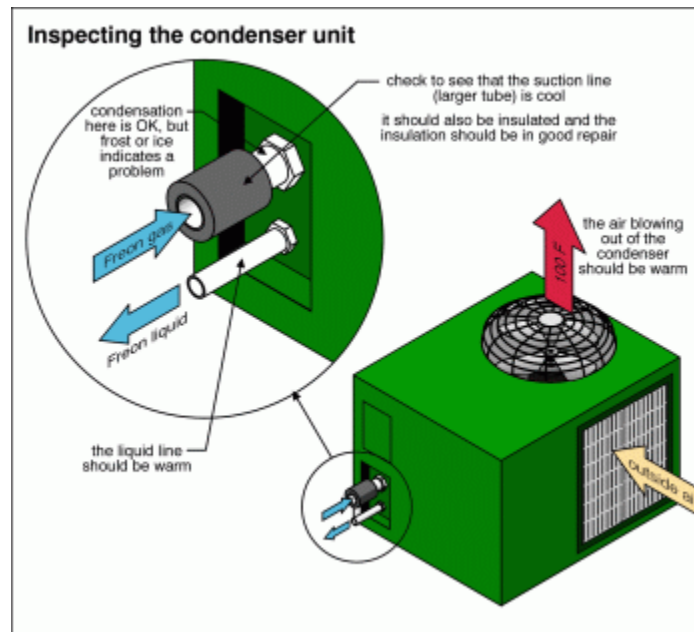
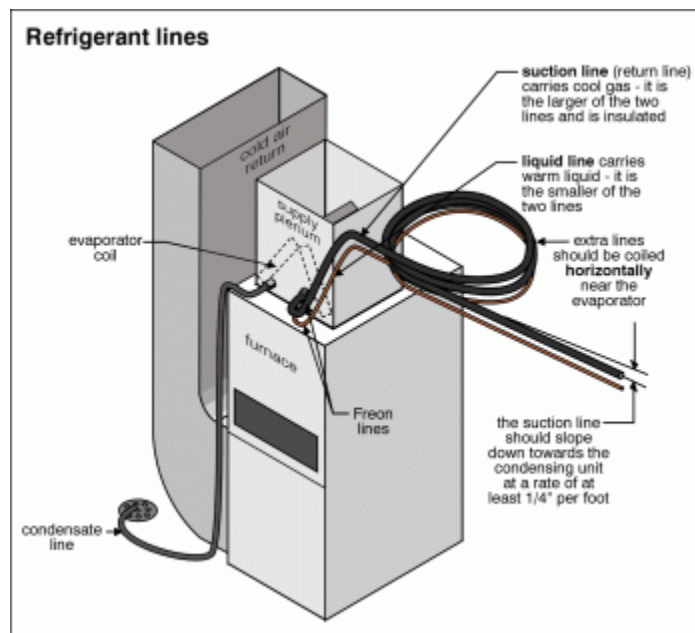
55. Condition: • [Missing insulation](#)

Damaged insulation on refrigerant lines should be repaired at the exterior.

Task: Repair
